Background

Glued-in rods (GiR) are an efficient alternative to traditional connections and reinforcement. However there are currently no pan-European standards for their design.

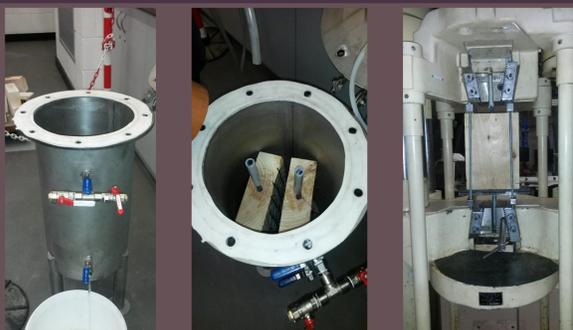
Research into the durability behaviour of GiR is limited. A pressure regime was used to simulate deteriorative effects of long term moisture ingress. Specimens were placed in a pressure vessel to saturate then were dried prior to ultimate strength testing.

Figure 6: Pressure soaking and testing

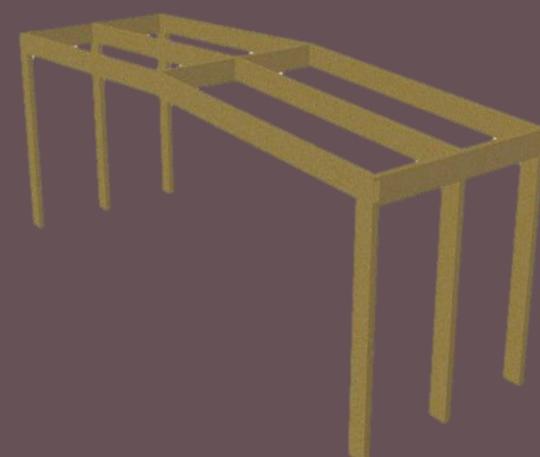
GiR as frame corner moment-resisting connections will be tested with frames constructed of OSB/C16 box sections.

Figure 8: Portal frame in timber box sections
